April 9, 2009

Subject: Updated Creek Stability Analysis Addressing the Cancer Center of  
Santa Barbara Redevelopment Project, Revised Site Plan

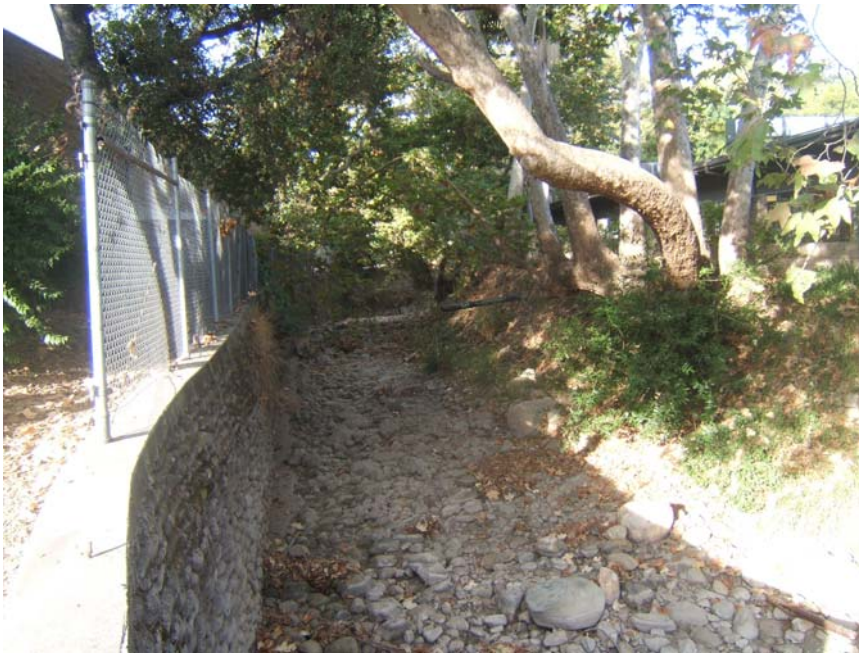
**Figure 2. Project site is along the right bank of the creek. Notice the large Sycamores at top of bank.**

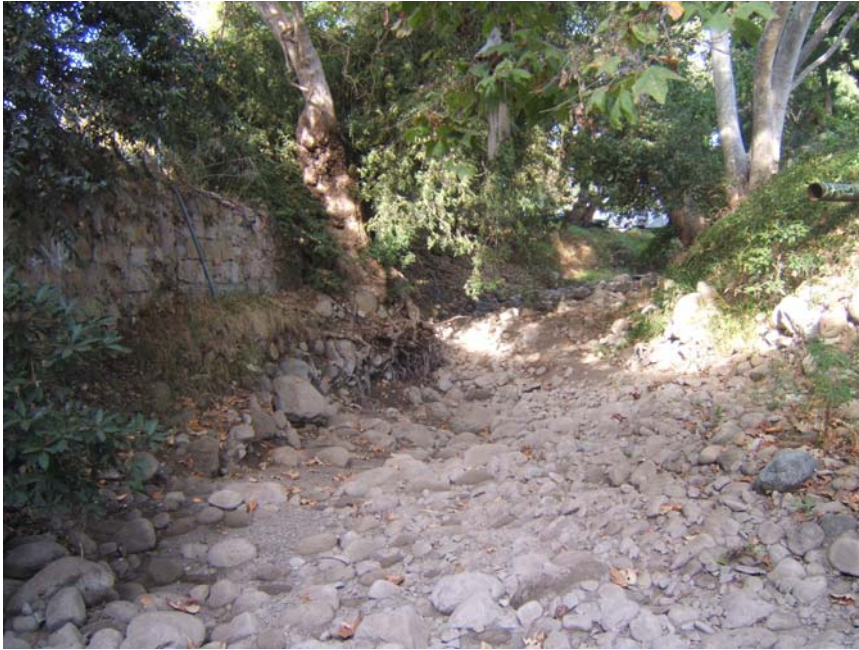
*Figure 3. Scour hole opposite the project site. Note under cut masonry wall above scour hole*

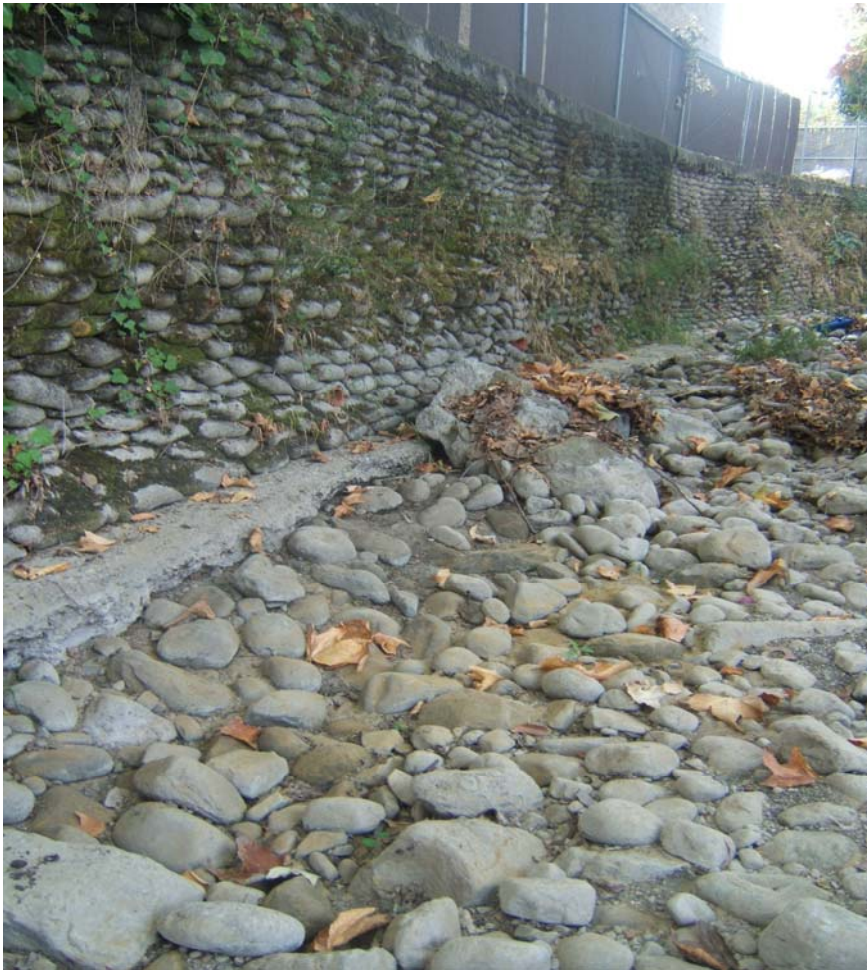
The existing stone masonry wall adjacent to the scour hole along the opposite bank of the project site is being under cut (**Figure 4**). If this wall collapses then flow may be diverted to the project bank toe, thereby initiating erosion on the project site. However because the new building will be set substantially back from the top of bank it is unlikely that any new erosion features will immediately impact the structure. It should be noted that neither the sackcrete wall nor the masonry wall referenced in this narrative or depicted in the report figures are on Cancer Center property. The erosion areas on the creek banks opposite the project site did not look particularly recent and may represent modest long-term degradation. It is unknown how deep the footings are but the sackcrete wall appeared to be stable and did not exhibit any signs of severe under cutting. It is recommended, however, that the masonry wall be monitored closely. Conditions found within Mission Creek adjacent to the project site are typical of many of the urban streams throughout Santa Barbara. Channel bed elevation may fluctuate several feet year-to-year based on flow regime and sediment input.

*Figure 4. Mission Creek channel – Sackcrete wall (looking upstream)*
